RE: **NOTICE OF VIOLATION NO. R9-2010-0027 &  
REQUIRED TECHNICAL REPORT**

**Subject Site: Mission Trails FRS II, Pipeline Tunnel and Vent Demolition Project**

FACILITY INSPECTION REPORT

FACILITY: **Mission Trails FRS II, Pipeline Tunnel and Vent Demo Project**

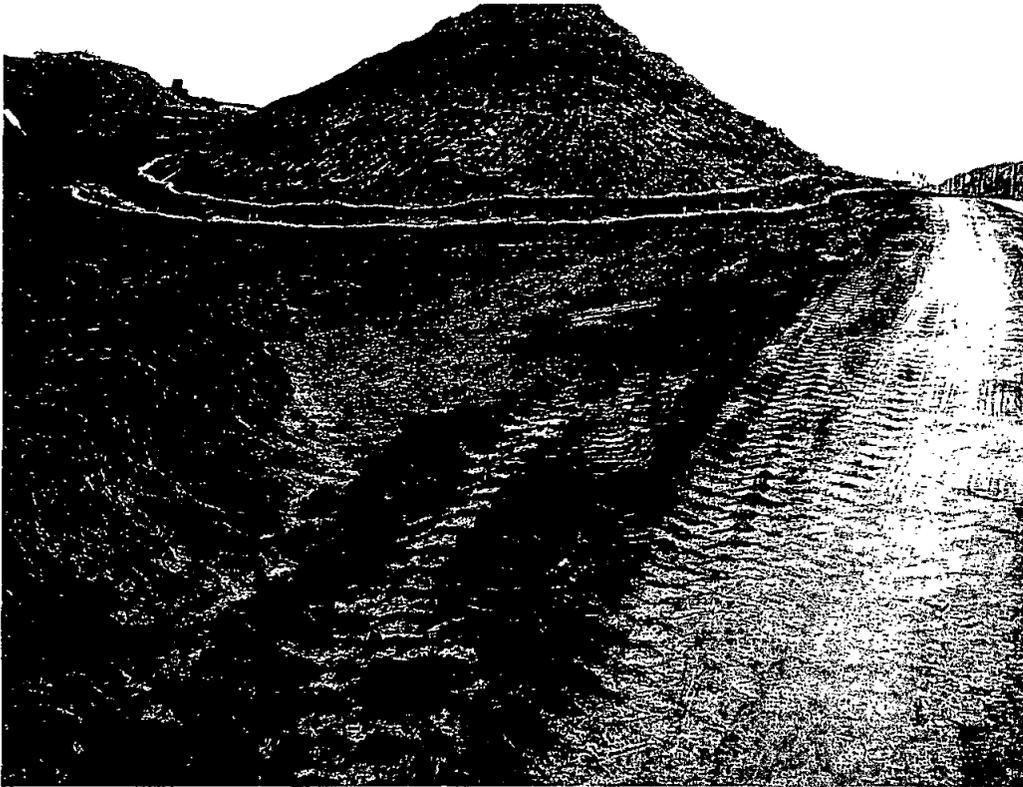
Looking uphill at temporary sediment stockpile and construction road. No erosion control BMPs have been deployed and rill erosion is evident.

- Erosion control BMPs should be deployed at all areas containing disturbed sediment.
- Sediment control BMPs should be enhanced, where needed.
- Construction debris should be removed or covered.
- The porta potty should be moved out of the natural flow line.
- The construction drawing showing BMPs as part of the SWPPP should be a living document and updated as needed. The drawing should be in a location easily accessible by all relevant parties and reflect the use of effective BMPs. As construction progresses and/or BMPs fail or need enhancement, the drawing should be updated.

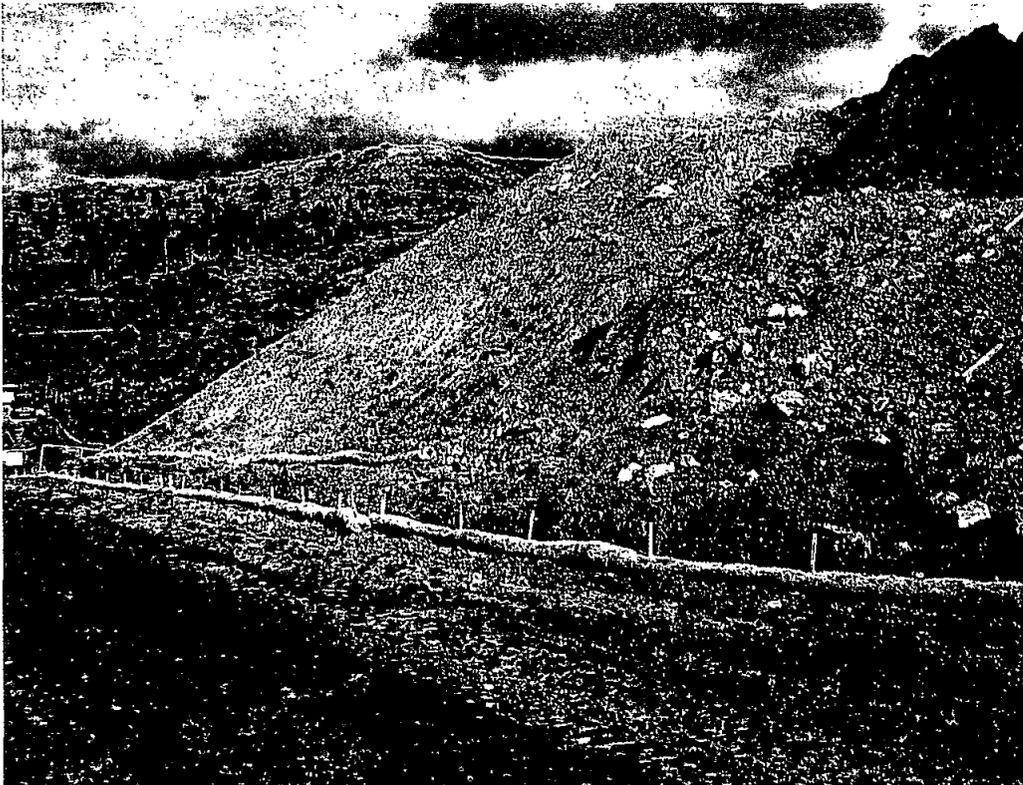
View of bare stockpile looking downhill. Note steepness of slope.

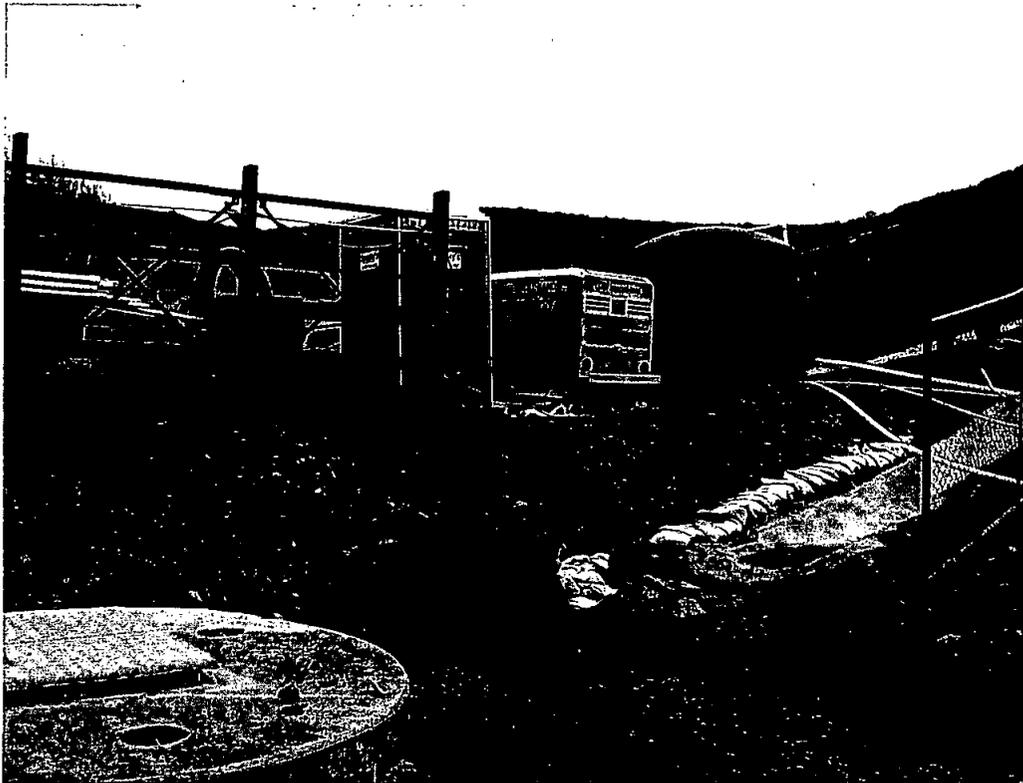
Culvert conveying small creek contains sediment, although not sure if this is project sediment or natural erosion of hillside. Note porta-potty is located in the natural flowline.

- Construction debris including rusty material was left uncovered and exposed to storm water. A porta-potty was placed in the path of a natural drainage.

- A culvert at the top of the hill on the south side of the site was half full of fine sediment, although it is not clear if this sediment originated from the construction site.

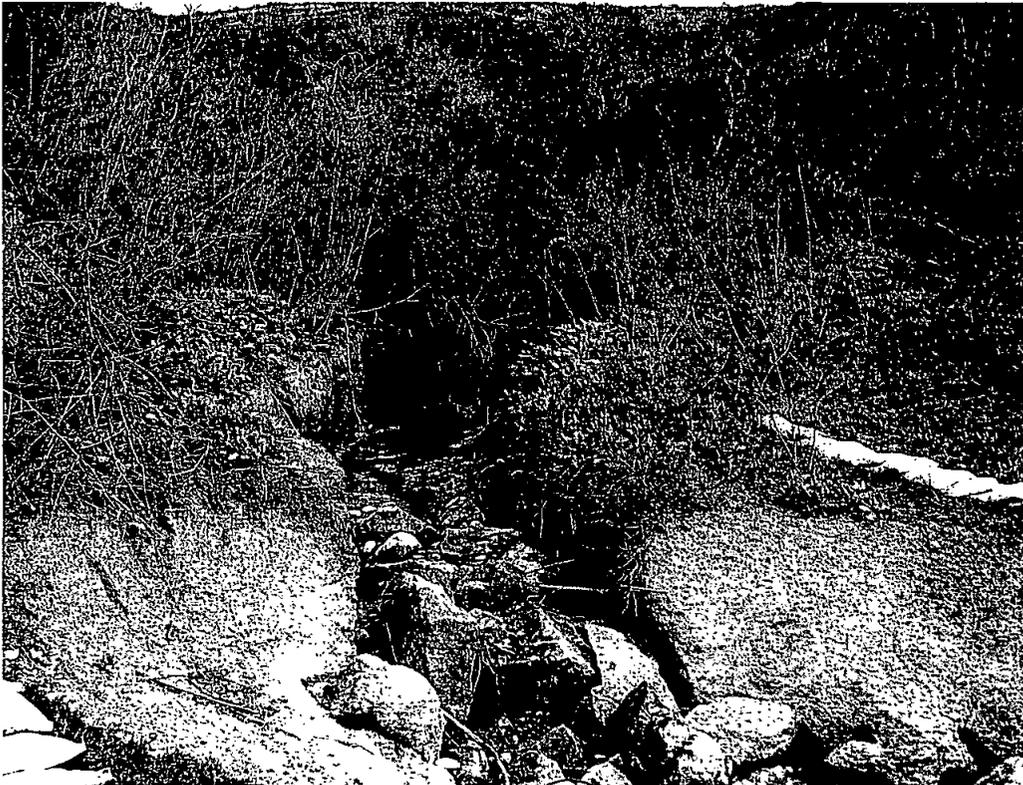
Natural creek drainage upstream of culvert in previous photo. Walls of creek bed have been stabilized with concrete.

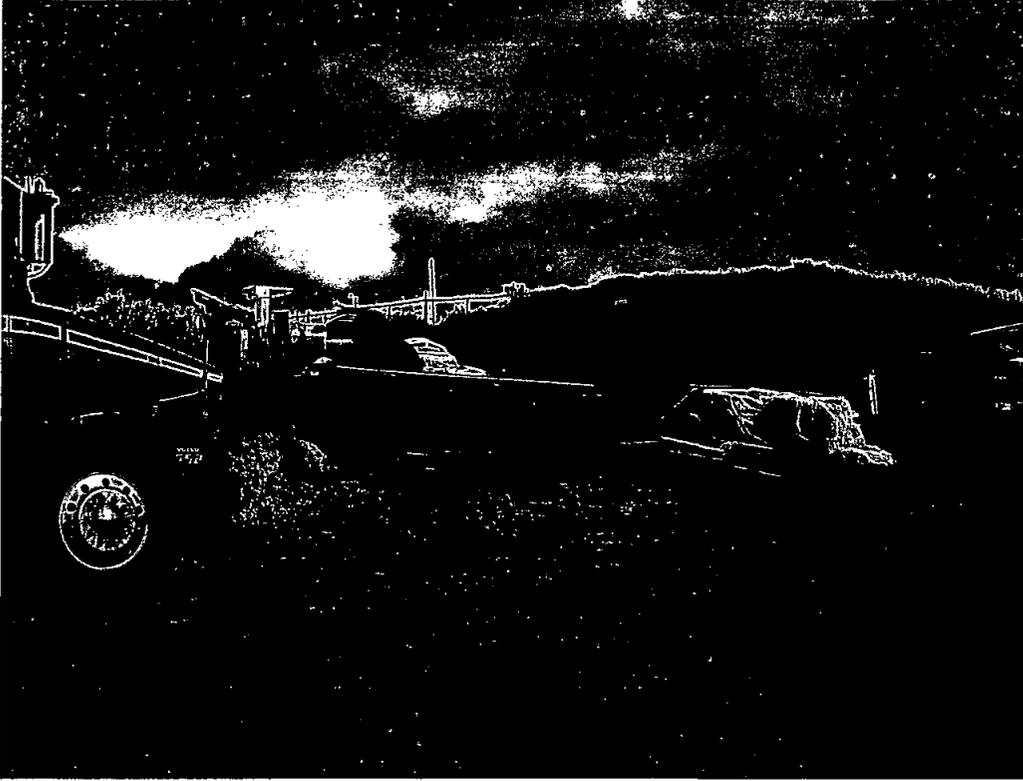
Construction debris and materials are uncovered and exposed.

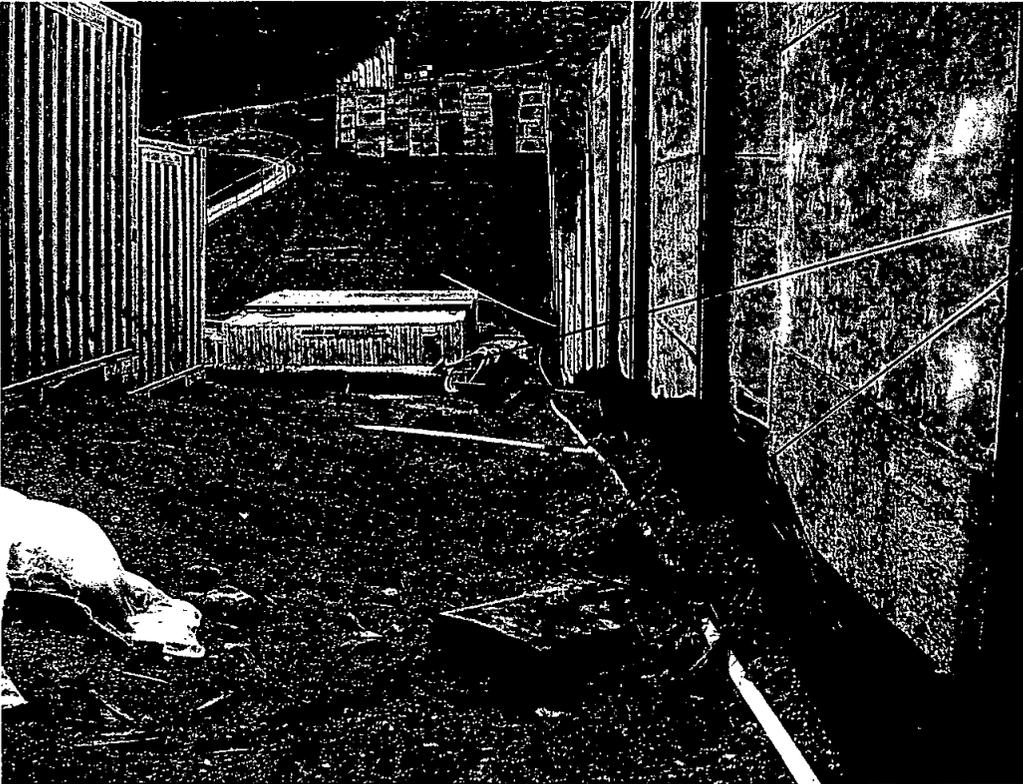
More exposed construction debris, including rusty pipes and equipment.

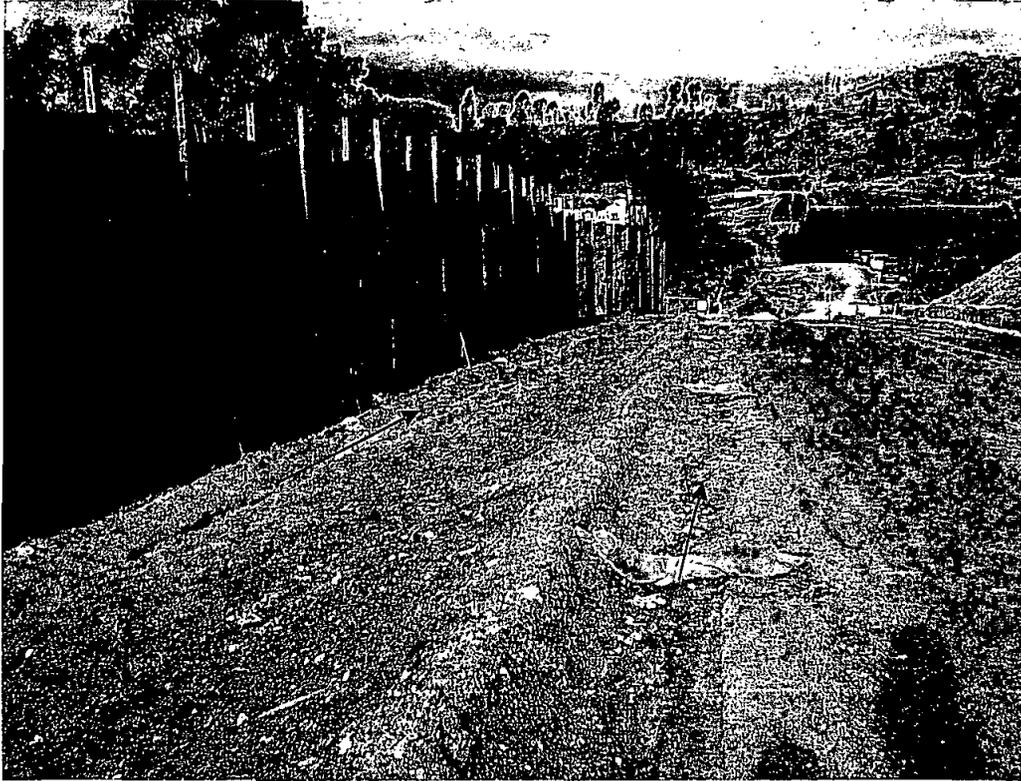
Looking north from top of hill towards creek. Berm on road side has caused channelization and concentrated flow.

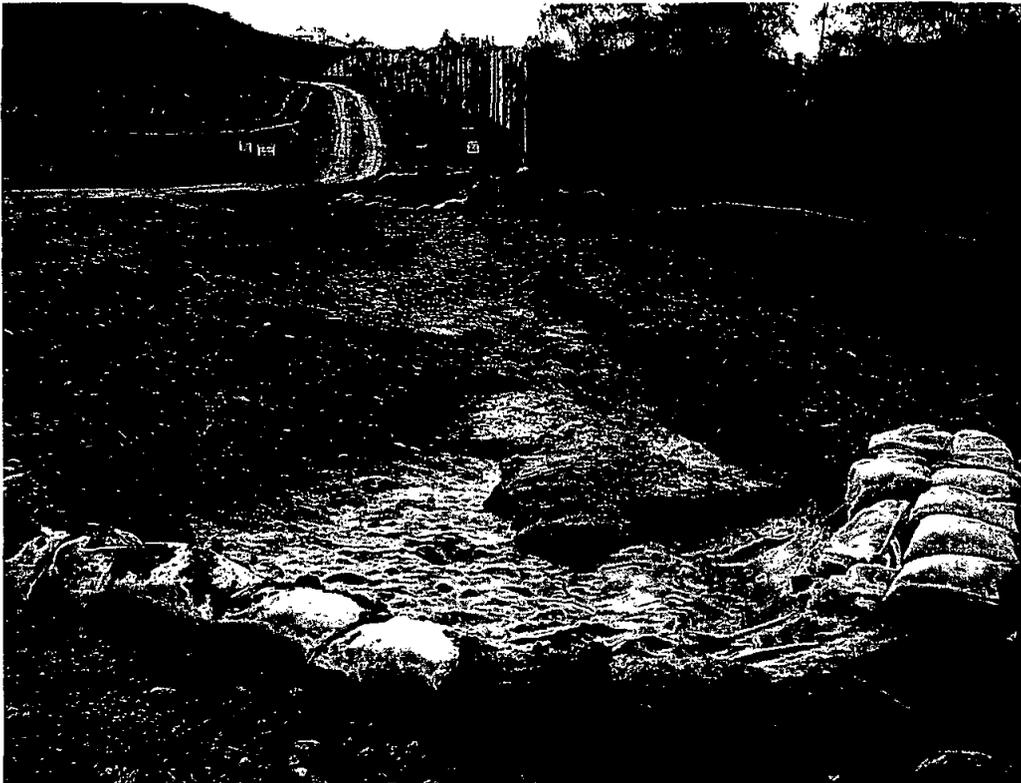
Looking south towards top of hill and stockpile. Some sediment has been captured but BMPs needs reinforcement with upcoming rain.

- Some sediment control BMPs were deployed but were insufficient at containing sediment onsite. In some cases, the capacity of the BMPs to contain the sediment has been reached, and more rain is expected.

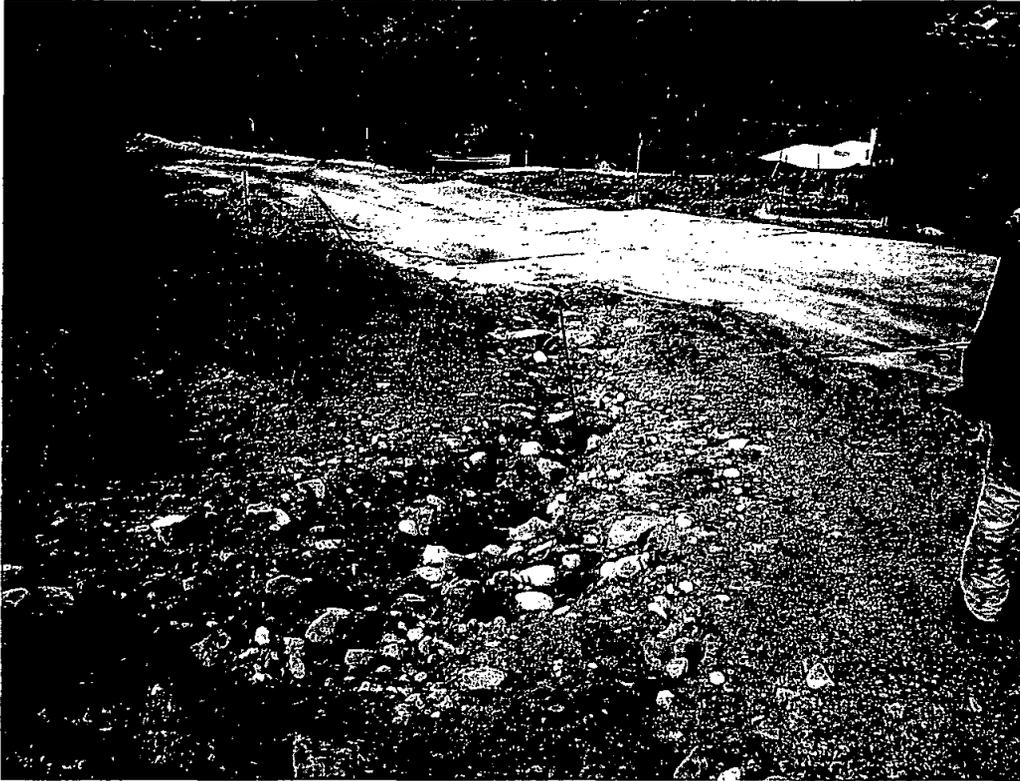
Bottom of hill. Note erosion shows flow line towards creek, which parallels road on far side.

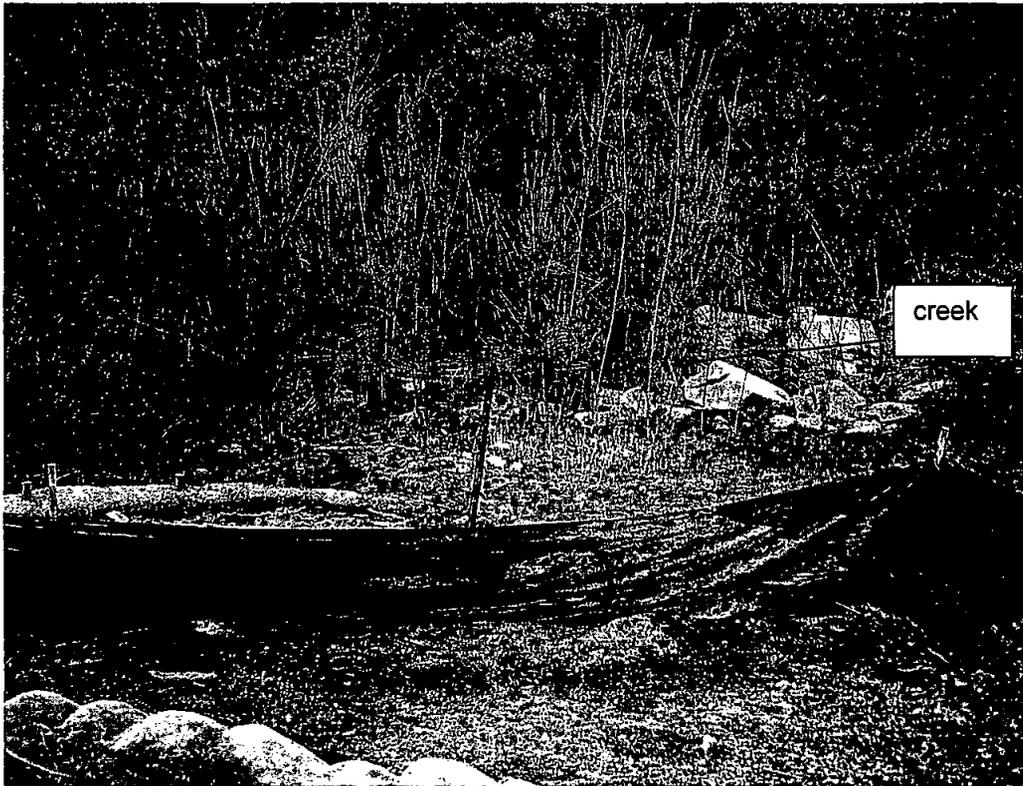
Silt fence is discolored showing evidence that sediment has breached this BMP. Sediment is also visible beyond straw waddle and in creek.

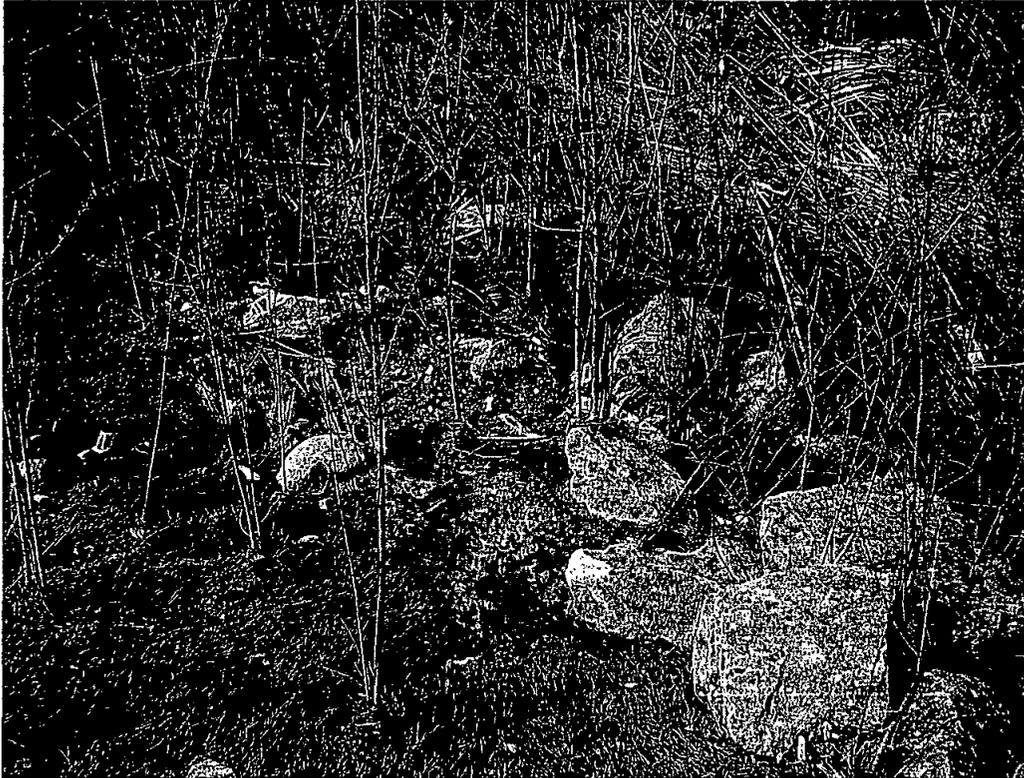
Project sediment shown visible in riprap--edge of creek.

- Fine sediment originating from the construction site was observed in the creek that parallels the main entry road. This is a violation of the General Construction Permit, the Basin Plan prohibitions, and the 401 Water Quality Certification.

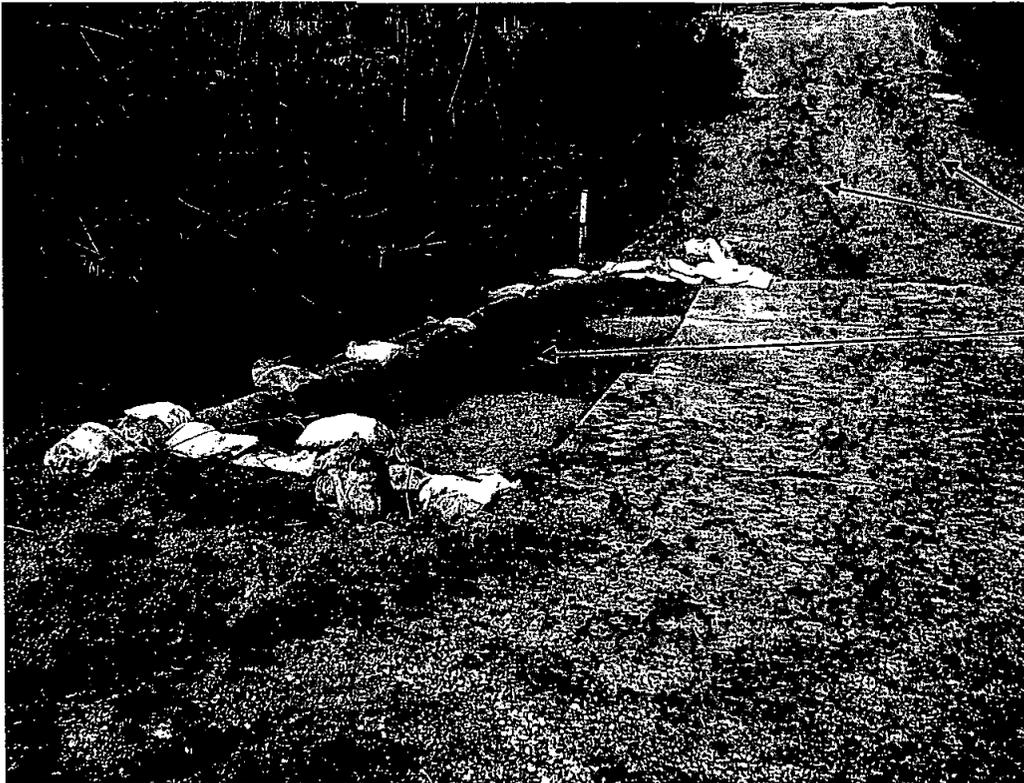
Looking at creek crossing (north direction). Project sediment is evident from discoloration looking uphill. Fine sediment is visible at edge of creek crossing.
